**Former Durant Middle School  
Durant, OK  
Remediation Final Report**

**Prepared by:  
Department of Environmental Quality  
707 North Robinson  
Oklahoma City, Oklahoma 73101**

**LIMITED LEAD-BASED PAINT SURVEY  
FORMER DURANT MIDDLE SCHOOL  
410 NORTH 6TH AVENUE  
DURANT, OKLAHOMA**

**ENERCON PROJECT NO. ENMISC3080**

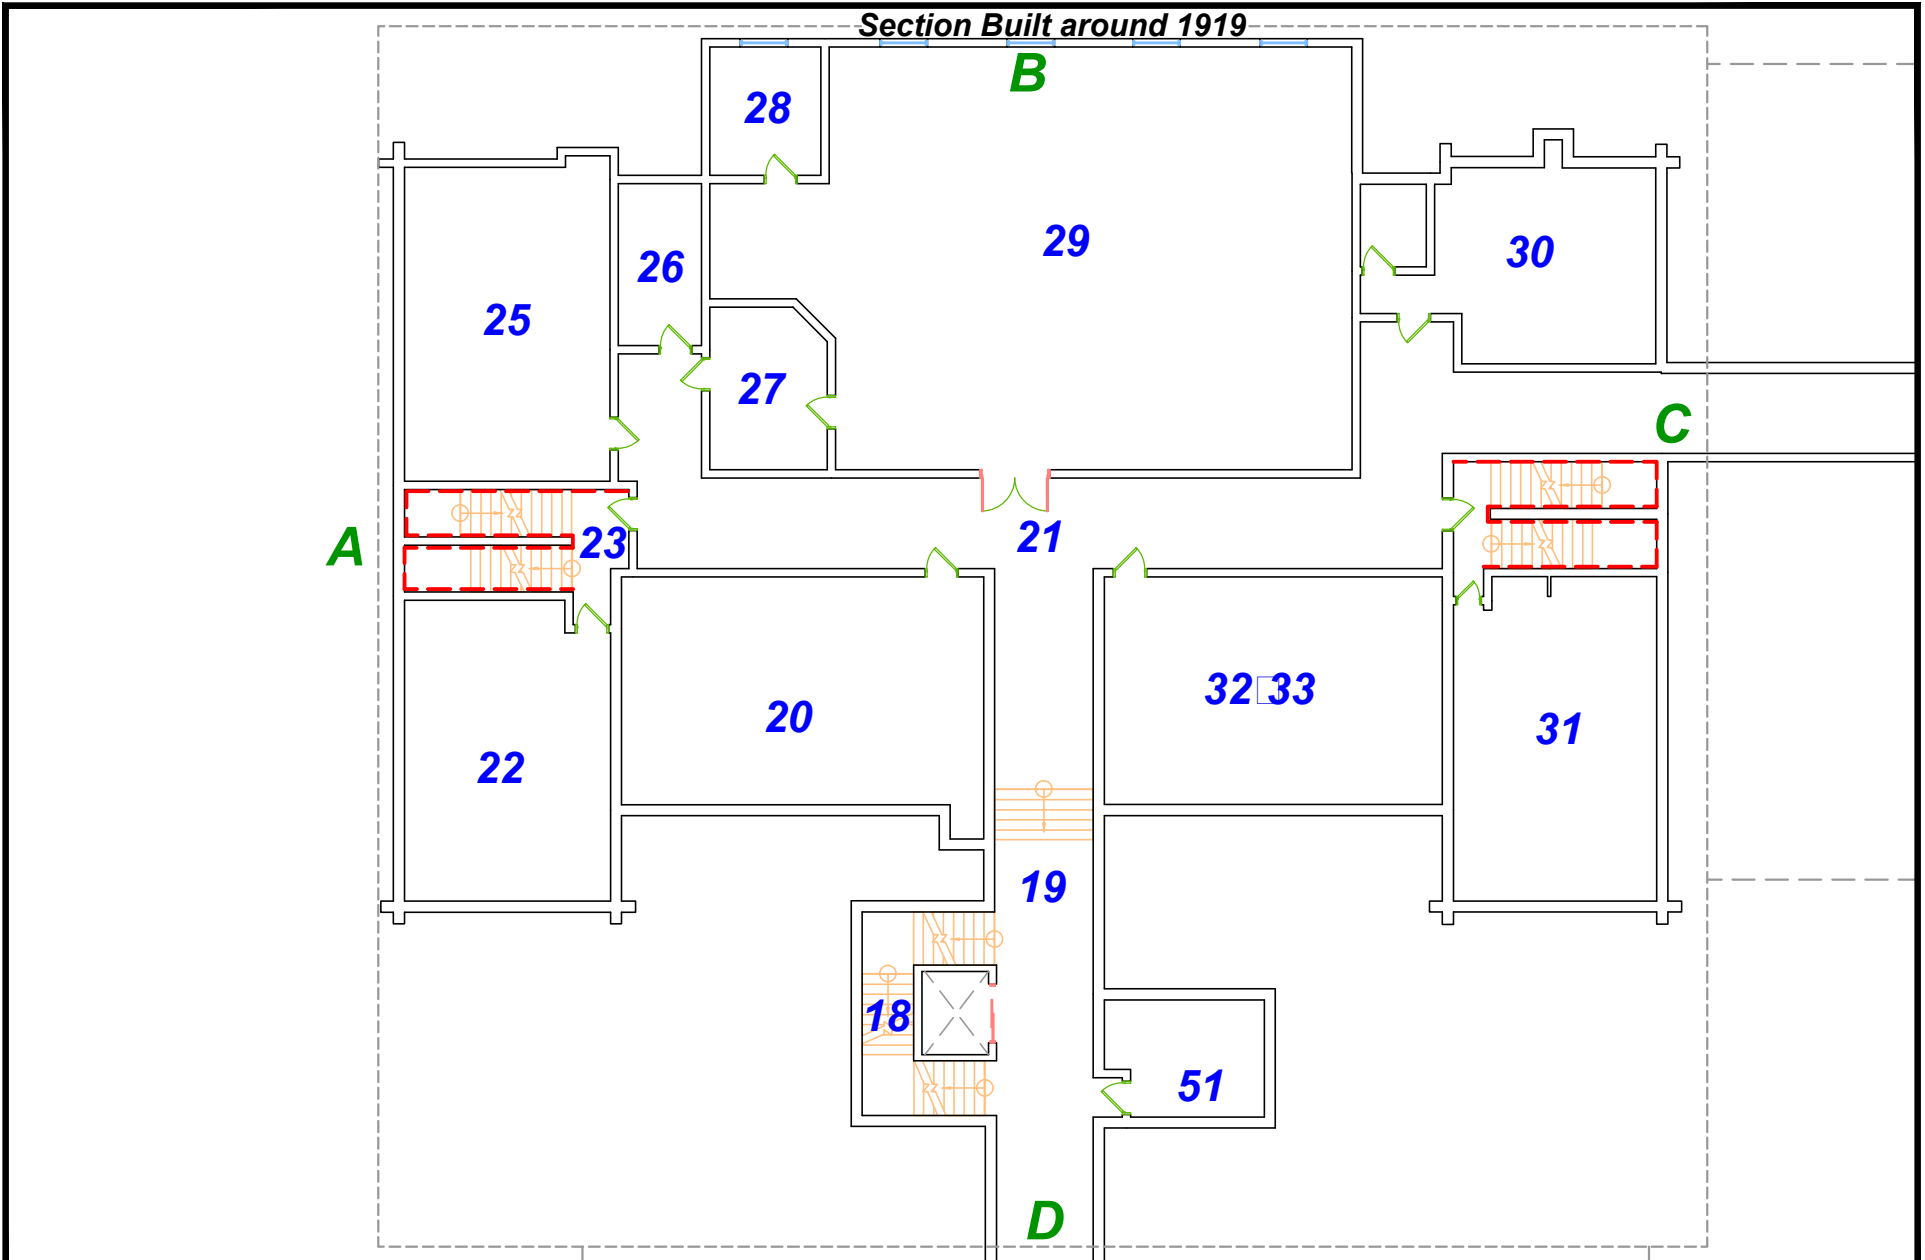
**LBP Locations Bld-1919**  
**Durant Middle School 2nd Floor**

**Legend:**  
 --- LBP on the lower four foot of walls and Banisters in stairwells @ 600SF

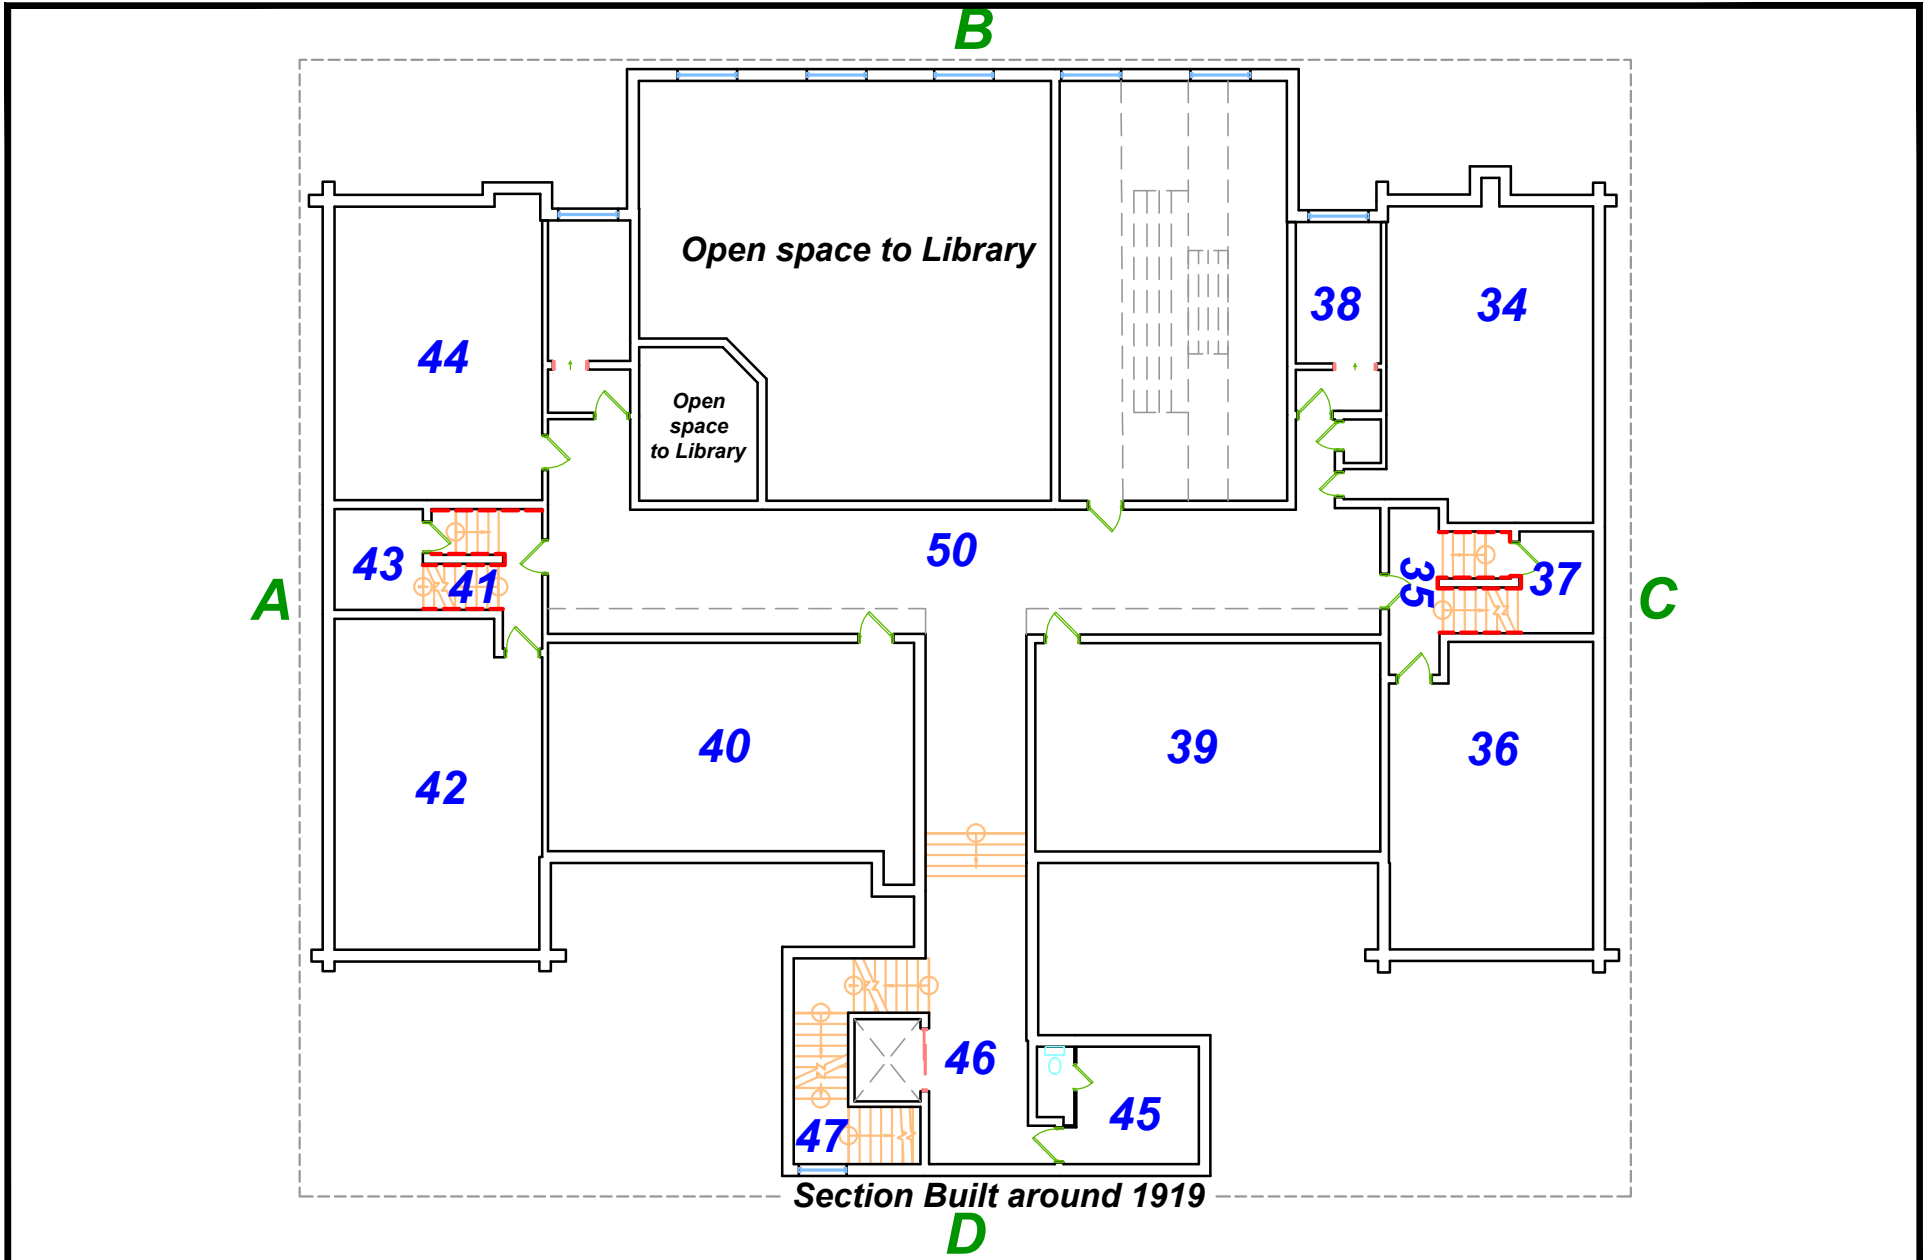
**Legend:**  
 - - - LBP on the lower four foot of walls and Banisters in stairwells @ 250 SF

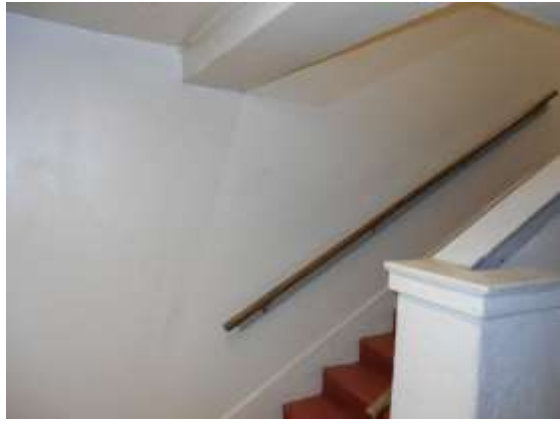
Photo #4: West Stairway Wall Bldg 1919

- Interior, Original Building (1919): LBP was present in good (intact) condition in the following locations:
  - The lower portion (approximately four feet) of the plaster walls and banisters in the east and west stairwells on all floors;
  - All four walls from floor to ceiling in Room #7;
  - Walls A, B and D from floor to ceiling in Room #9;
  - Wall A from floor to ceiling in Room #15.
- Interior, 1964 Building: No painted surfaces were found to contain LBP.
- Exterior, Both Buildings: No exterior painted surfaces were found to have LBP.

- Lead based paint (LBP) inspection
- LBP abatement, consisting of:
  - Encapsulation of LBP in the stairwells

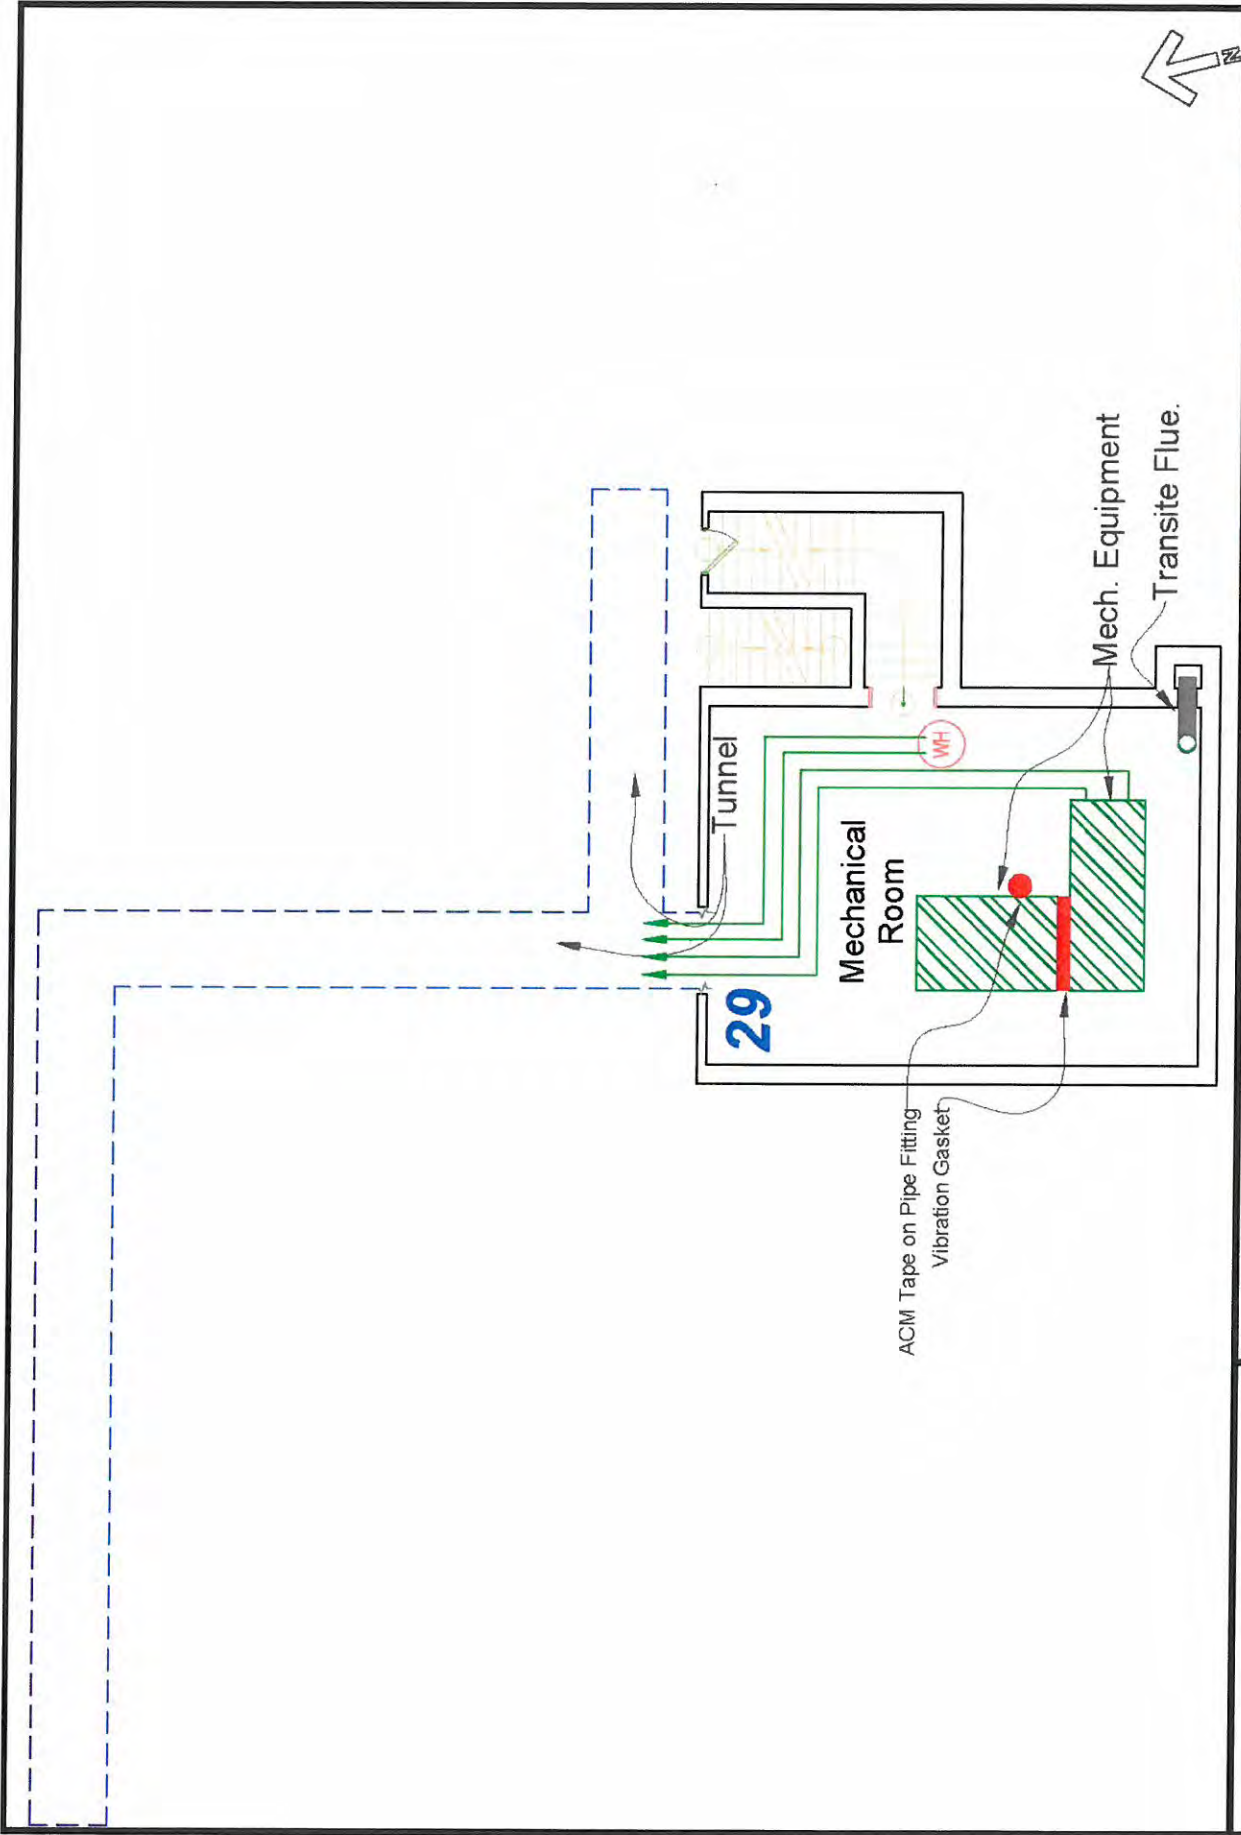
Basement  
Asbestos Locations

vibration isolation gasket. The piping in the tunnel had fiberglass insulation on the lines with asbestos-cement on the fittings. The utility tunnel was visibly contaminated due to deteriorated insulation on some of the fittings. The quantity of fittings in the tunnel was estimated. Piping from the tunnel penetrated to the first floor to serve radiators, restroom fixtures, janitor sinks and water fountains. Piping risers on the first floor served radiators on the second floor. Some of these risers were enclosed in walls or chases and the piping inside was presumed to have fiberglass line insulation and asbestos-cement fittings insulated in the same manner as the accessible piping in this building. Piping at the radiators on the second floor was not insulated. Piping serving restrooms and other fixtures where the piping was inside walls/chases was also not accessible for inspection and was presumed to be insulated consistent with that which was accessible. The quantity of insulated fittings in these inaccessible locations was estimated. It is possible that the domestic water piping inside interior walls/chases is not insulated; however, for scoping purposes it is more reasonable to presume that the insulation is consistent with that which is visible. This will need to be verified during renovation that might disturb the fitting insulation.

The majority of the piping with ACM-insulated fittings is located in a pipe tunnel that has some damaged insulation with contaminated soil beneath the piping runs. Access to this area is limited. Piping from the tunnel penetrates the first floor to serve radiators on the second floor with this piping enclosed in risers and is presumed to be insulated in the same manner as that in the tunnel. Domestic water piping serving restrooms and other fixtures on the first and second floors is located inside walls or chases and is also presumed to be insulated in the same manner as that in the tunnel. Selective demolition will be necessary for access to this inaccessible piping to confirm that it contains asbestos with additional demolition for abatement if the presence of asbestos is confirmed and abatement is planned. Estimated quantities have been incorporated into the survey to enable planning for abatement of all asbestos in the building should that be desired.

Should complete abatement not be the selected option, the fitting insulation and contamination in the tunnel may be 1) abated, 2) abandoned in place and the tunnel entrance sealed or 3) repaired and managed in place. If all asbestos is not removed, preparation and implementation of an Asbestos Management Plan is recommended for management of the asbestos in place.
