**Former Durant Middle School  
Durant, OK  
Remediation Final Report**

**Prepared by:  
Department of Environmental Quality  
707 North Robinson  
Oklahoma City, Oklahoma 73101**

**LIMITED LEAD-BASED PAINT SURVEY  
FORMER DURANT MIDDLE SCHOOL  
410 NORTH 6TH AVENUE  
DURANT, OKLAHOMA**

**ENERCON PROJECT NO. ENMISC3080**

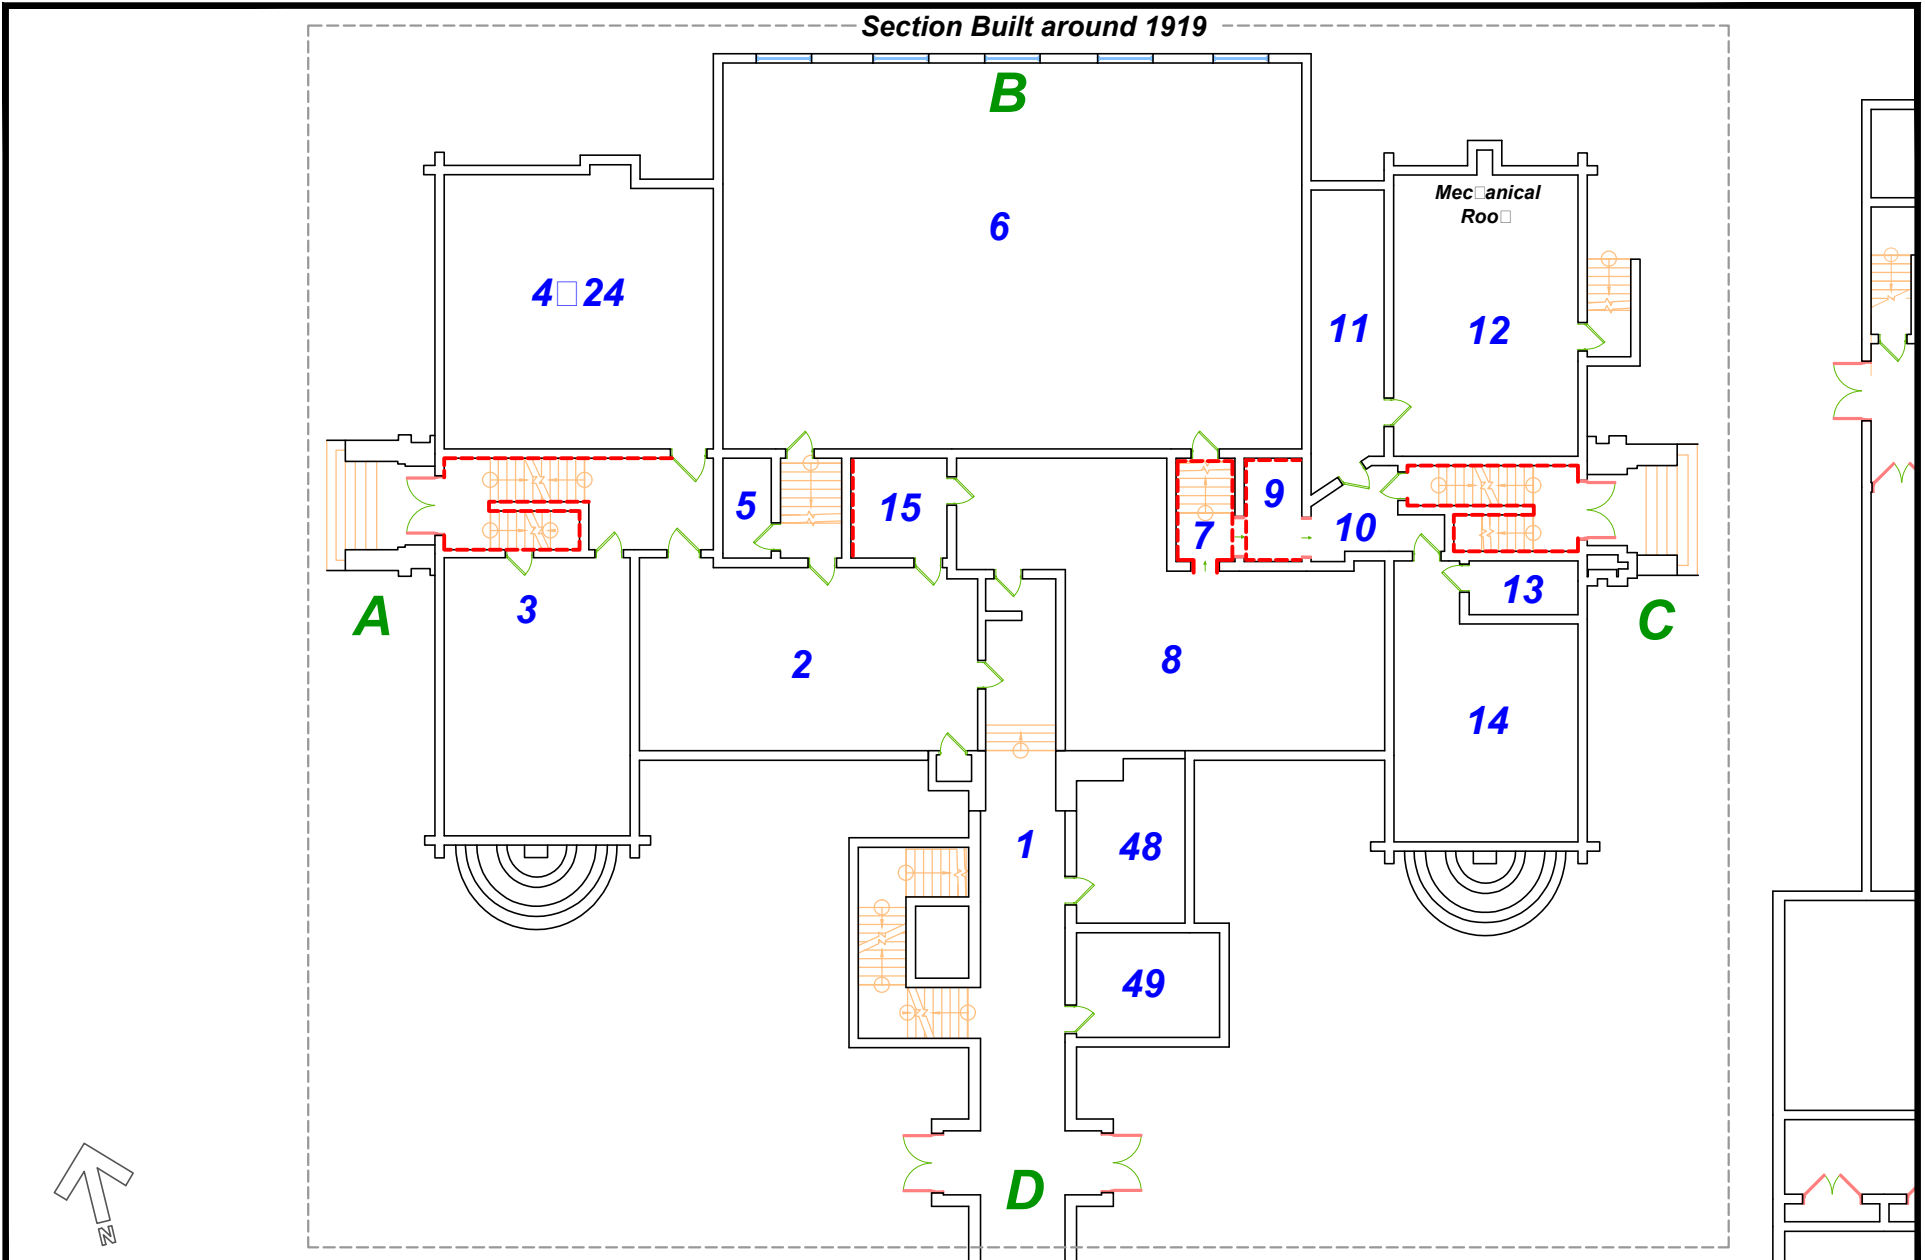
Site Layouts with Areas of LBP

- Interior, Original Building (1919): LBP was present in good (intact) condition in the following locations:
  - The lower portion (approximately four feet) of the plaster walls and banisters in the east and west stairwells on all floors;
  - All four walls from floor to ceiling in Room #7;
  - Walls A, B and D from floor to ceiling in Room #9;
  - Wall A from floor to ceiling in Room #15.
- Interior, 1964 Building: No painted surfaces were found to contain LBP.
- Exterior, Both Buildings: No exterior painted surfaces were found to have LBP.

Interior Surfaces: The only interior painted surfaces with LBP were located in the original 1919 building. These were limited to three small rooms and the main stairwells. The LBP was in intact condition. The total area with LBP was estimated at 1,835 square feet.

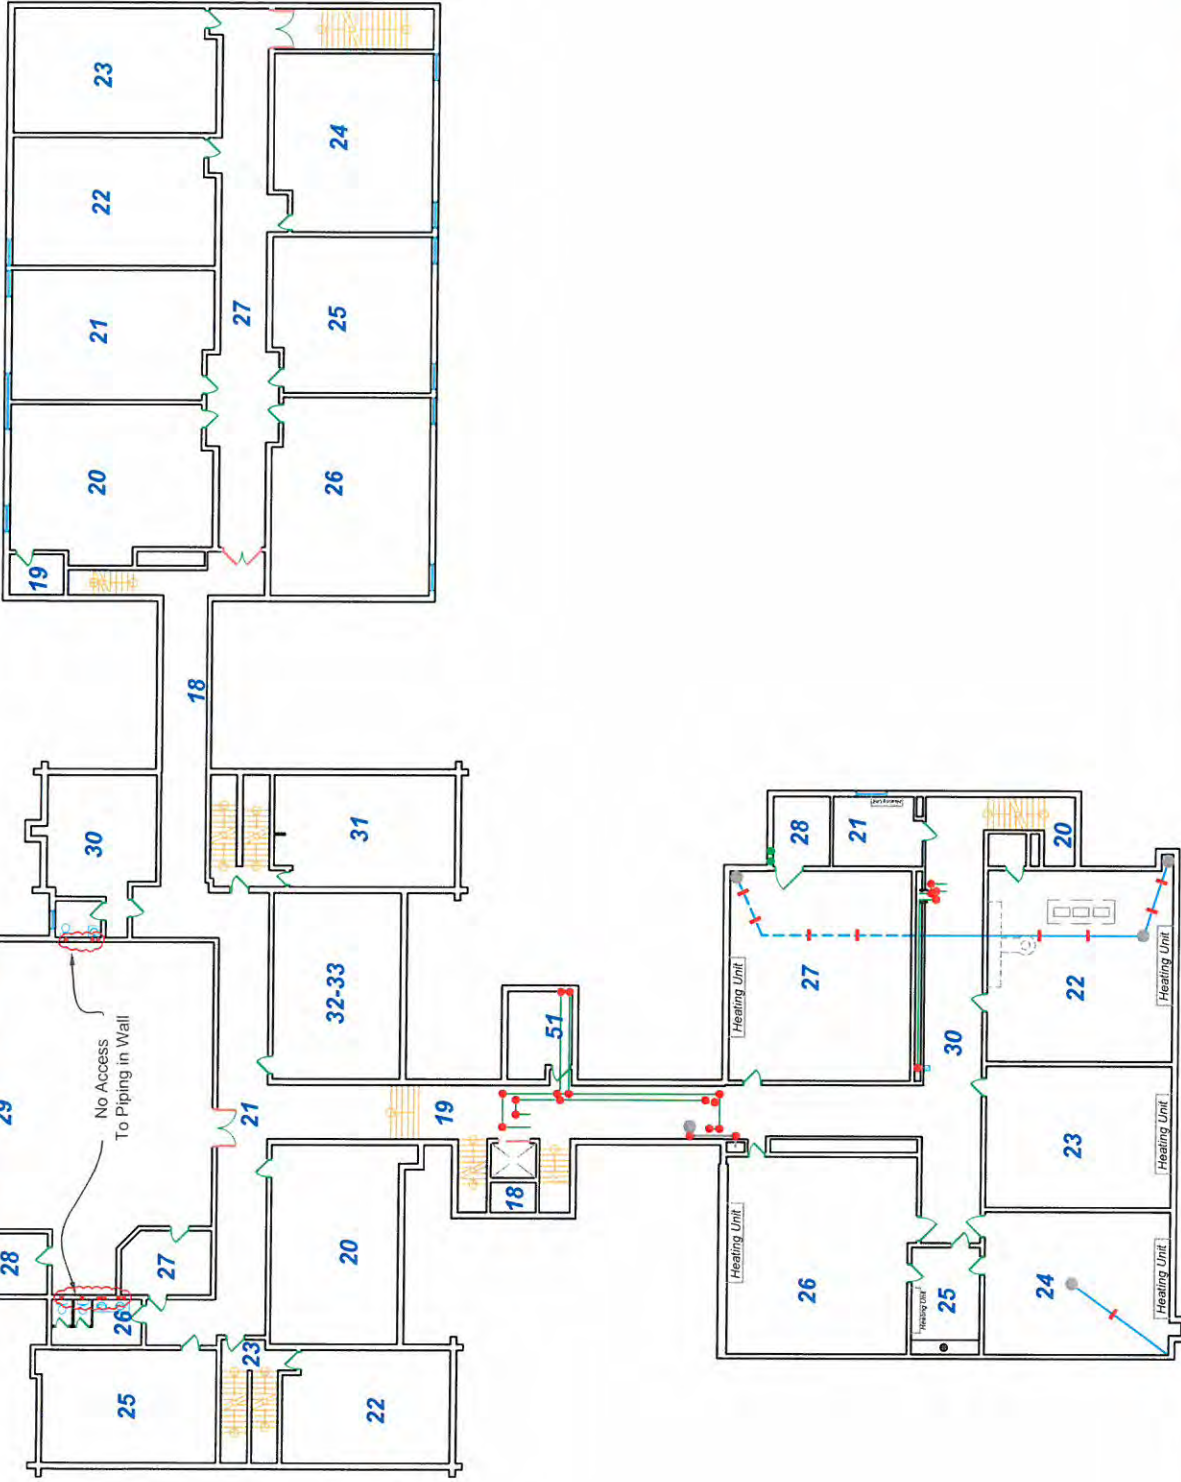
**Second Floor Asbestos Locations  
Durant Middle School**

- = Roof Drain Lines
- - - = Roof Drain Line Path Assumed
- = Roof Drain Pans
- = Asbestos Containing Hangers @ 9 Each
- = Asbestos Fittings Approximately 40 Each

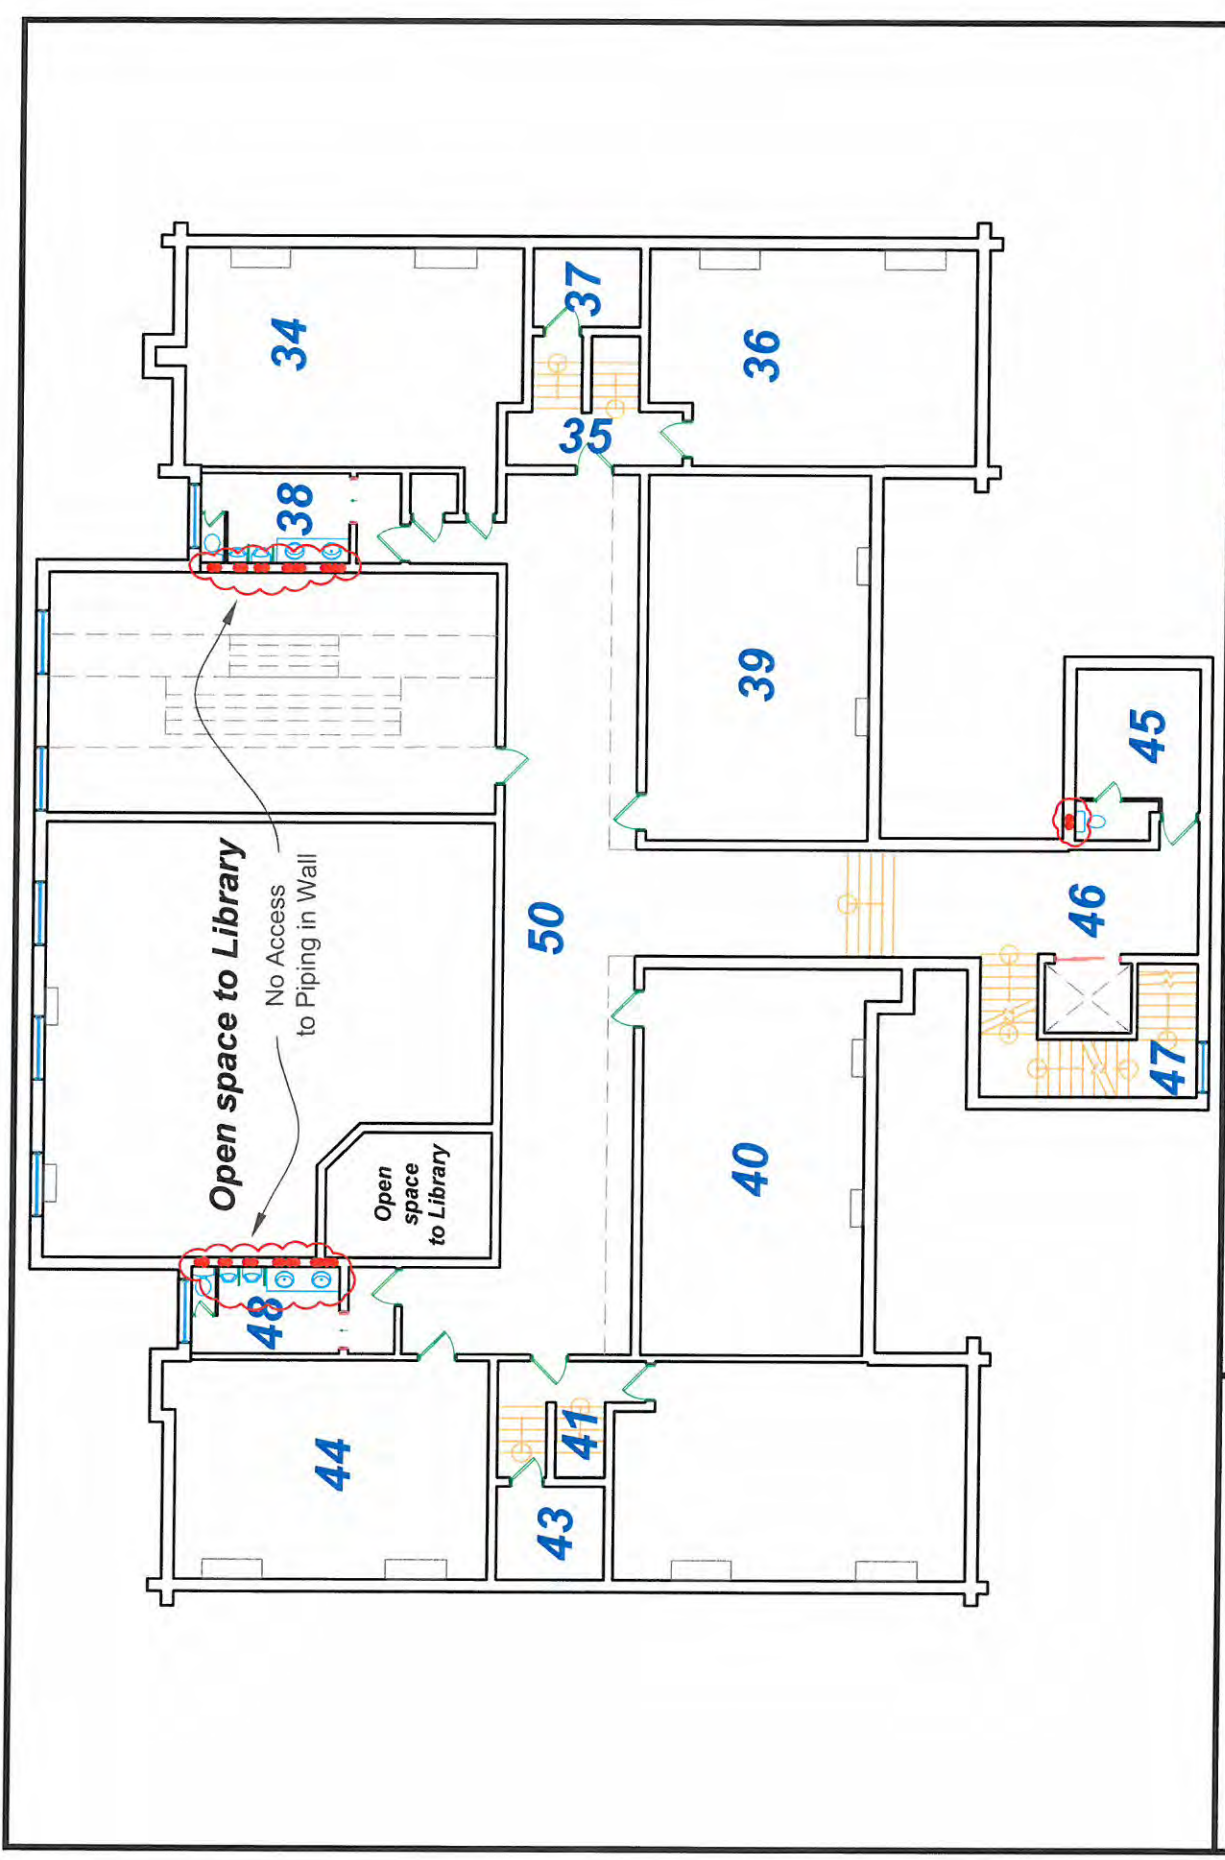
Third Floor Pipe Fitting Locations  
Durant Middle School

**Legend:**  
● = Presumed Asbestos Fitting Locations @ 30 Each

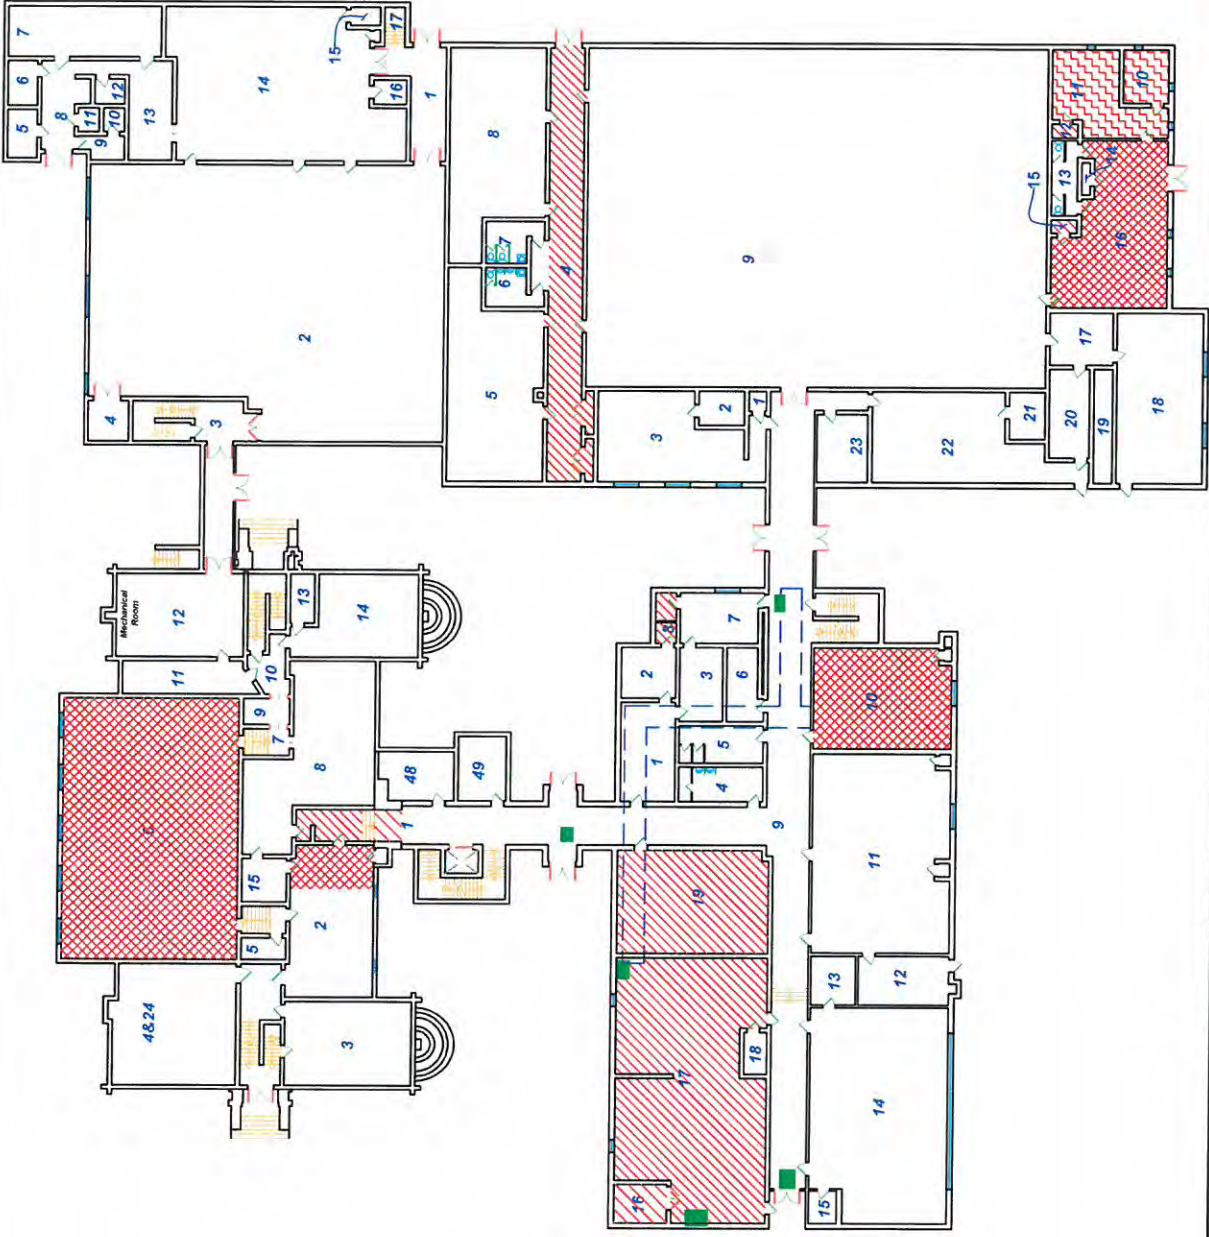
**ENERCON**  
 First Floor Tile Locations  
 Durant Middle School

**Legend:**  
 = Floor Tile and Mastic @ 3,640 SF  
 = ACM Mastic Only @ 4,100 SF  
 = Floor Tile and Mastic under Carpet @ 500 SF

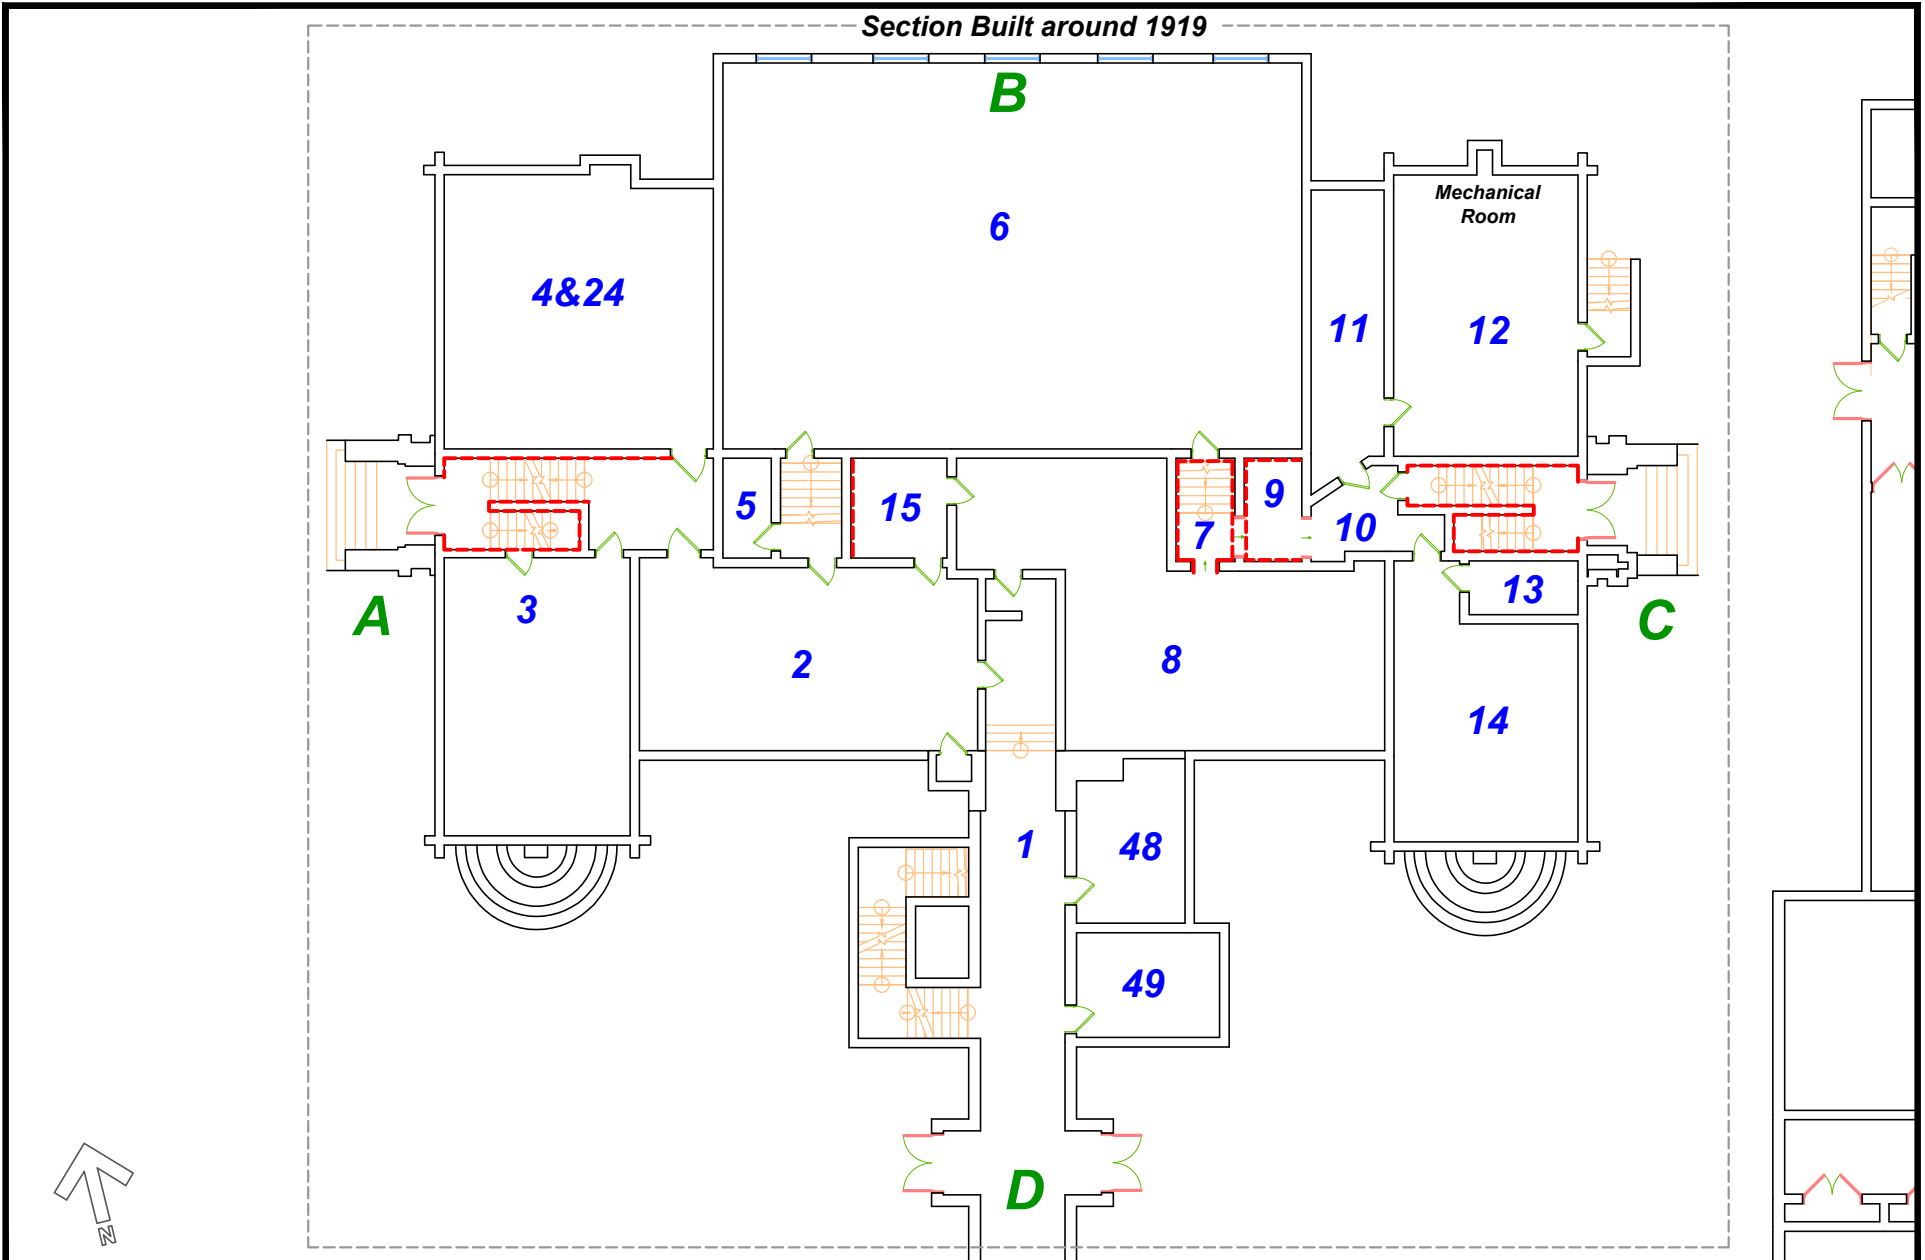
**LBP Locations Bld-1919**  
 Durant Middle School 1 St Floor

**Legend:**  
 --- LBP on the lower four foot of walls and Banisters in stairwells, other marked areas are coated with LBP floor to ceiling @ 985 - SF

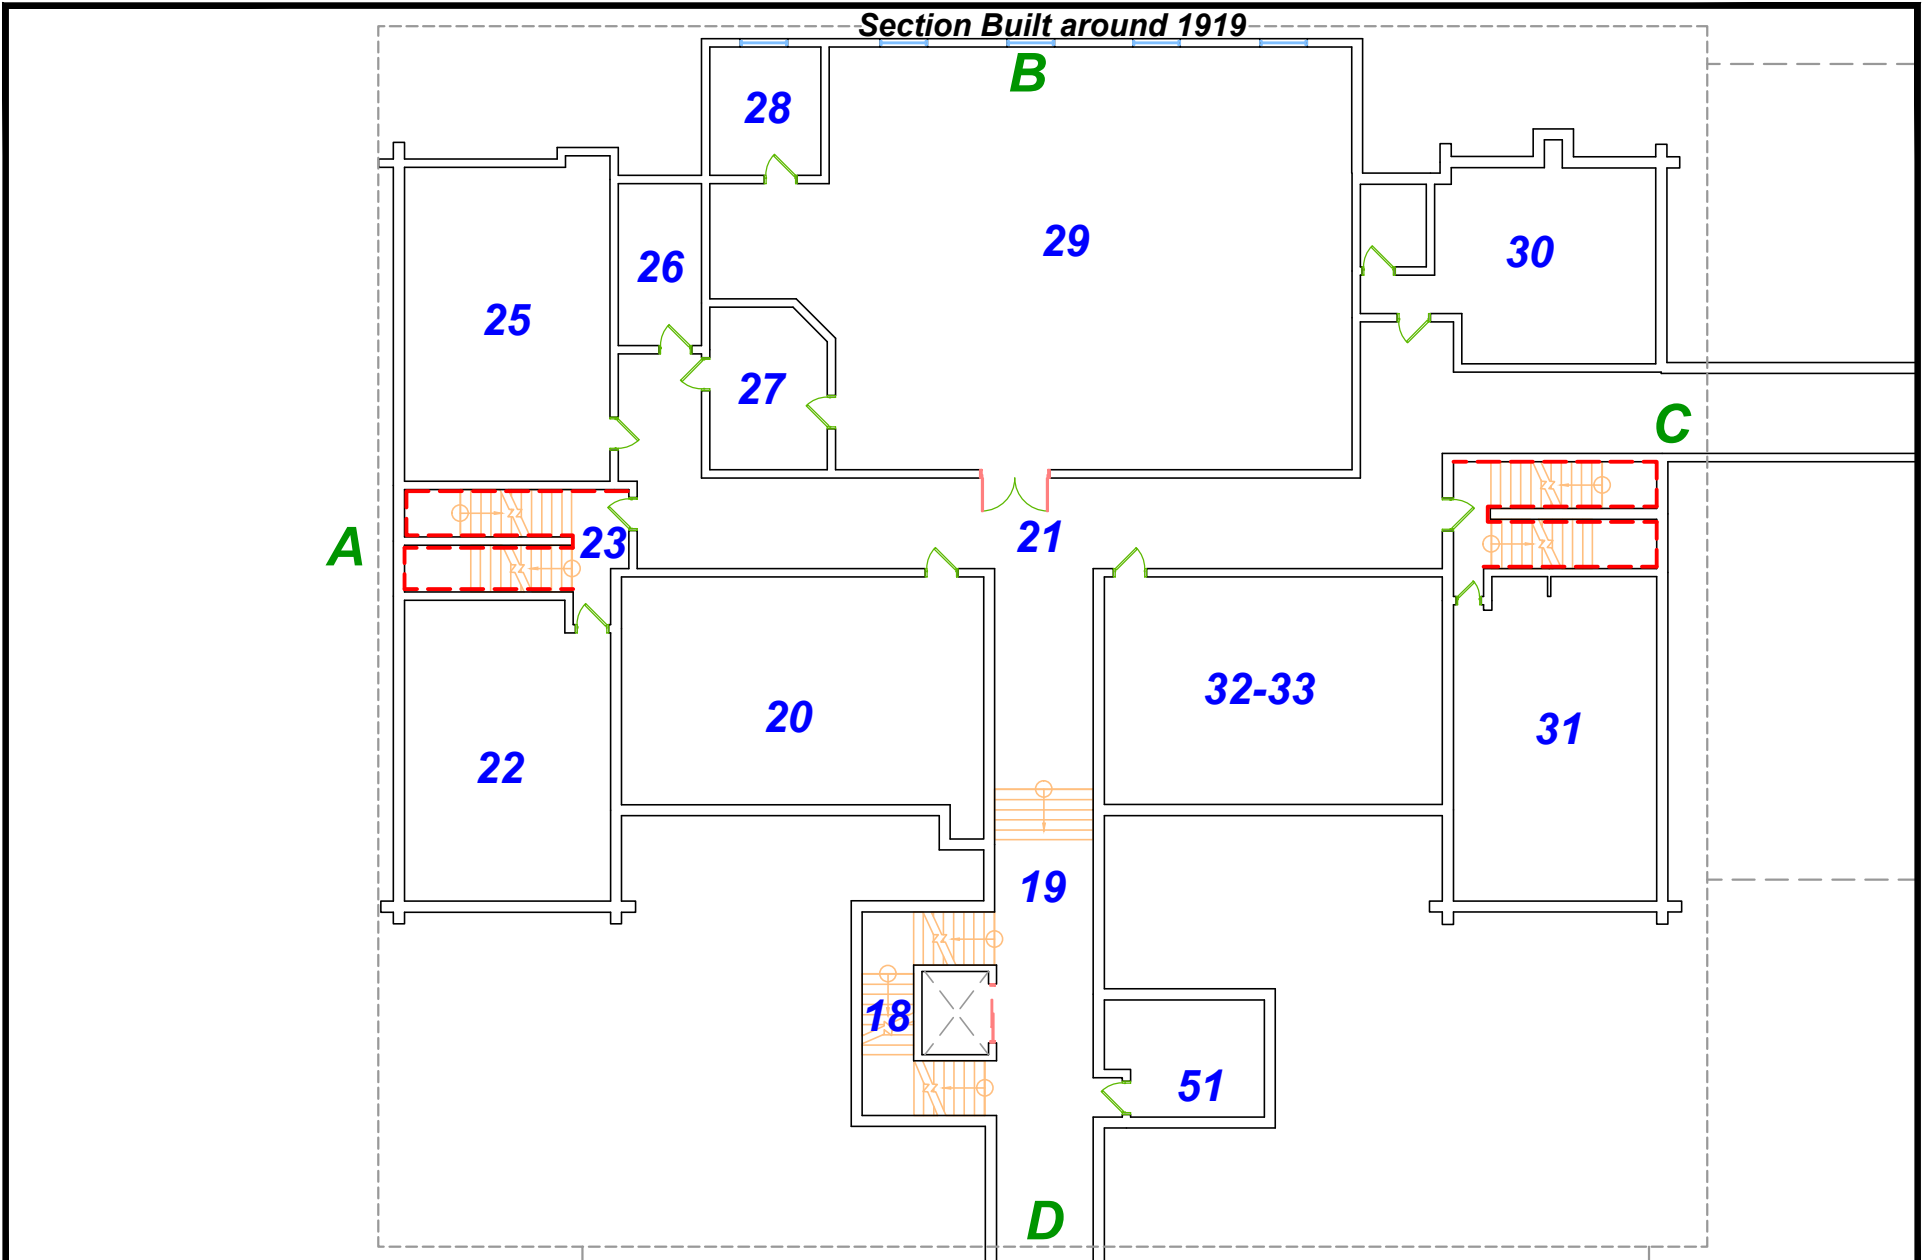
**Legend:**  
 - - - LBP on the lower four foot of walls and Banisters in stairwells @ 600SF

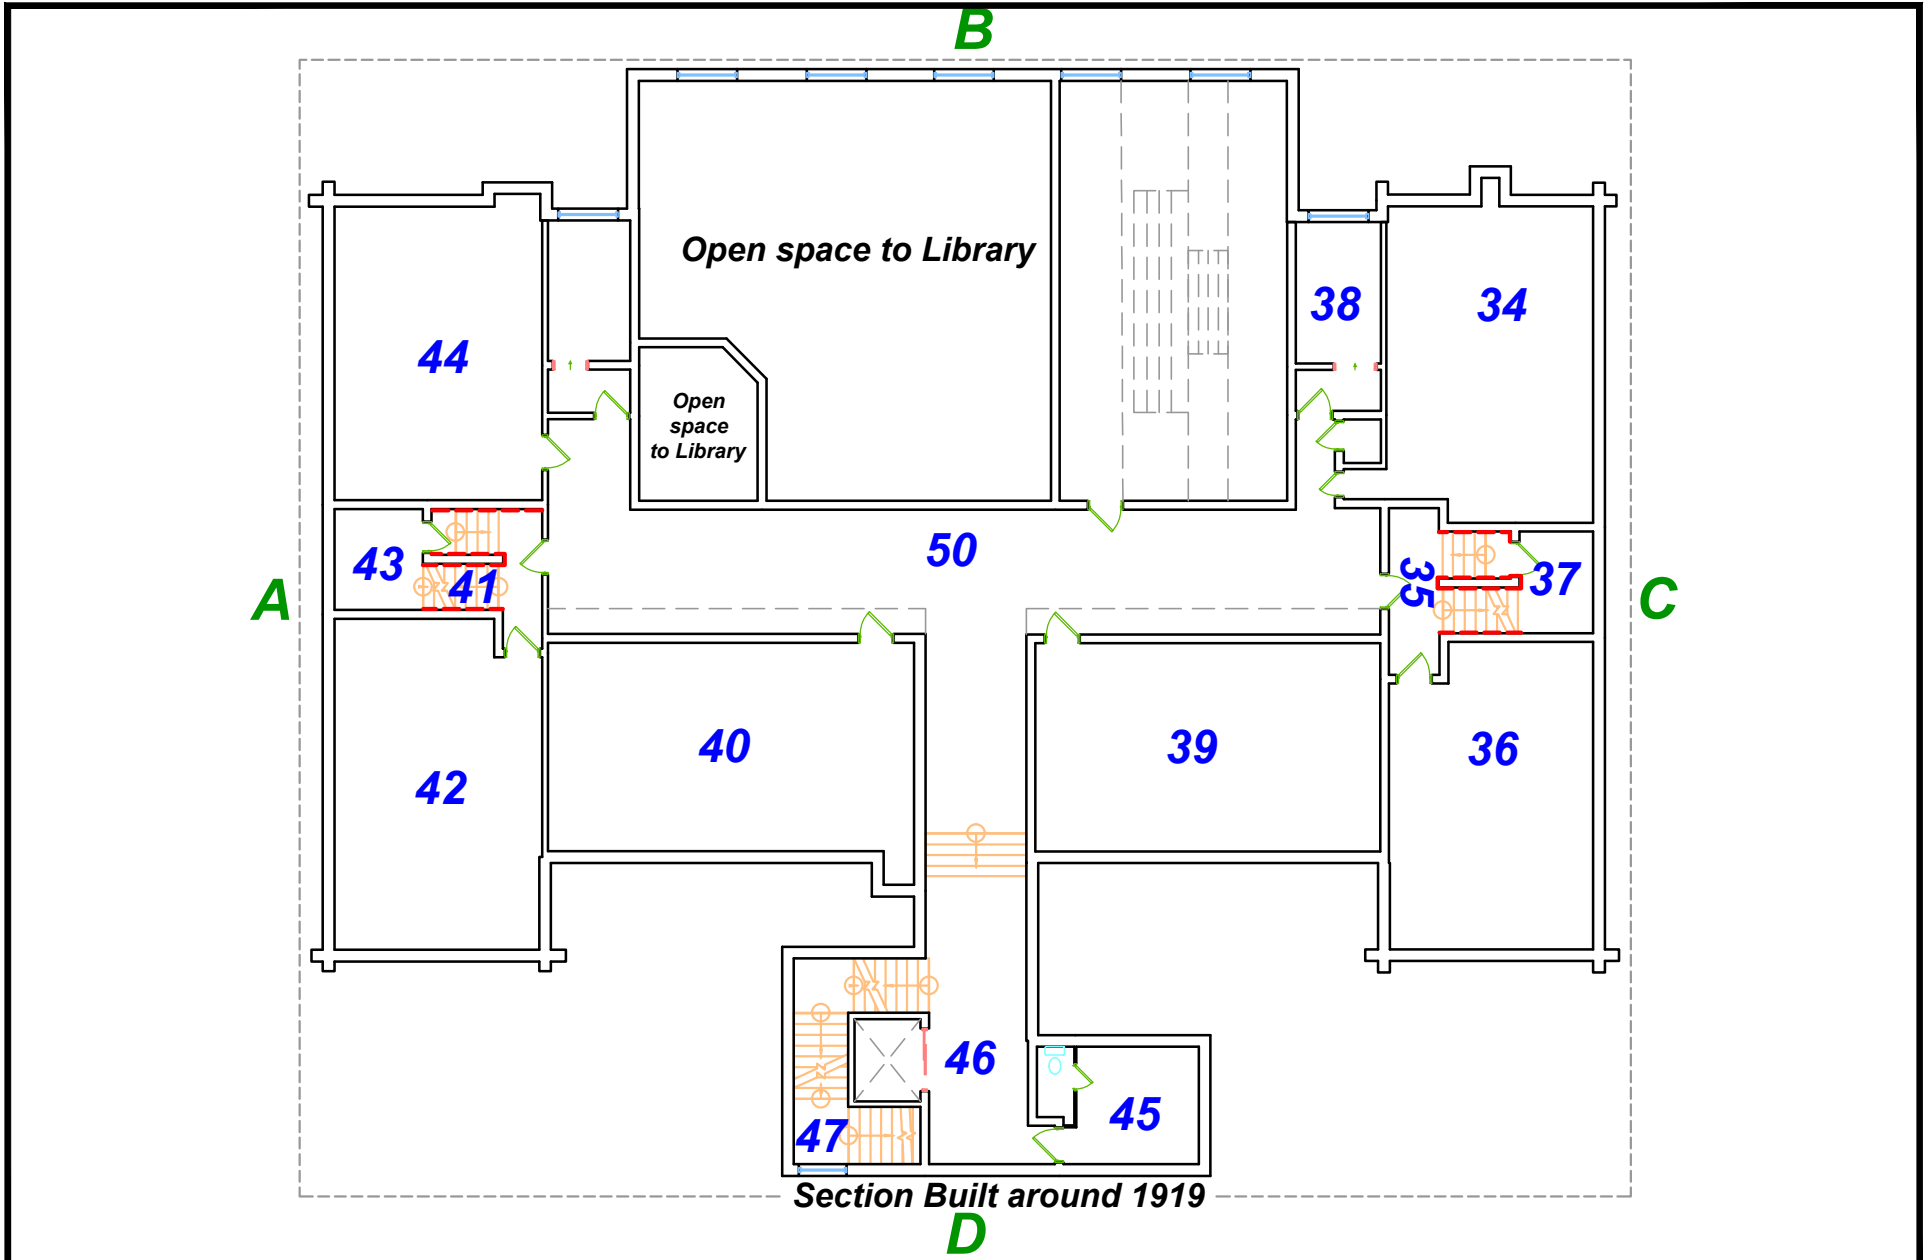
**LBP Locations Bld-1919**  
**Durant Middle School 2nd Floor**

1. Stairwell in 1910 building – Walls containing lead-based paint were cleaned and sealed with lead based paint encapsulant. These surfaces need to be resealed if encapsulant shows signs of deterioration, damage, or flaking. See attachment 1 for floor plan maps with locations of encapsulated lead-based paint marked in red.
